**NPDES
INSPECTION REPORT**

**WASTEWATER TREATMENT FACILITY
PARMA, IDAHO**

**INSPECTION DATE: June 6, 2012
REPORT DATE: June 20, 2012**

**Prepared By:
Michael Spomer
Technical Services
Idaho Department of Environmental Quality**

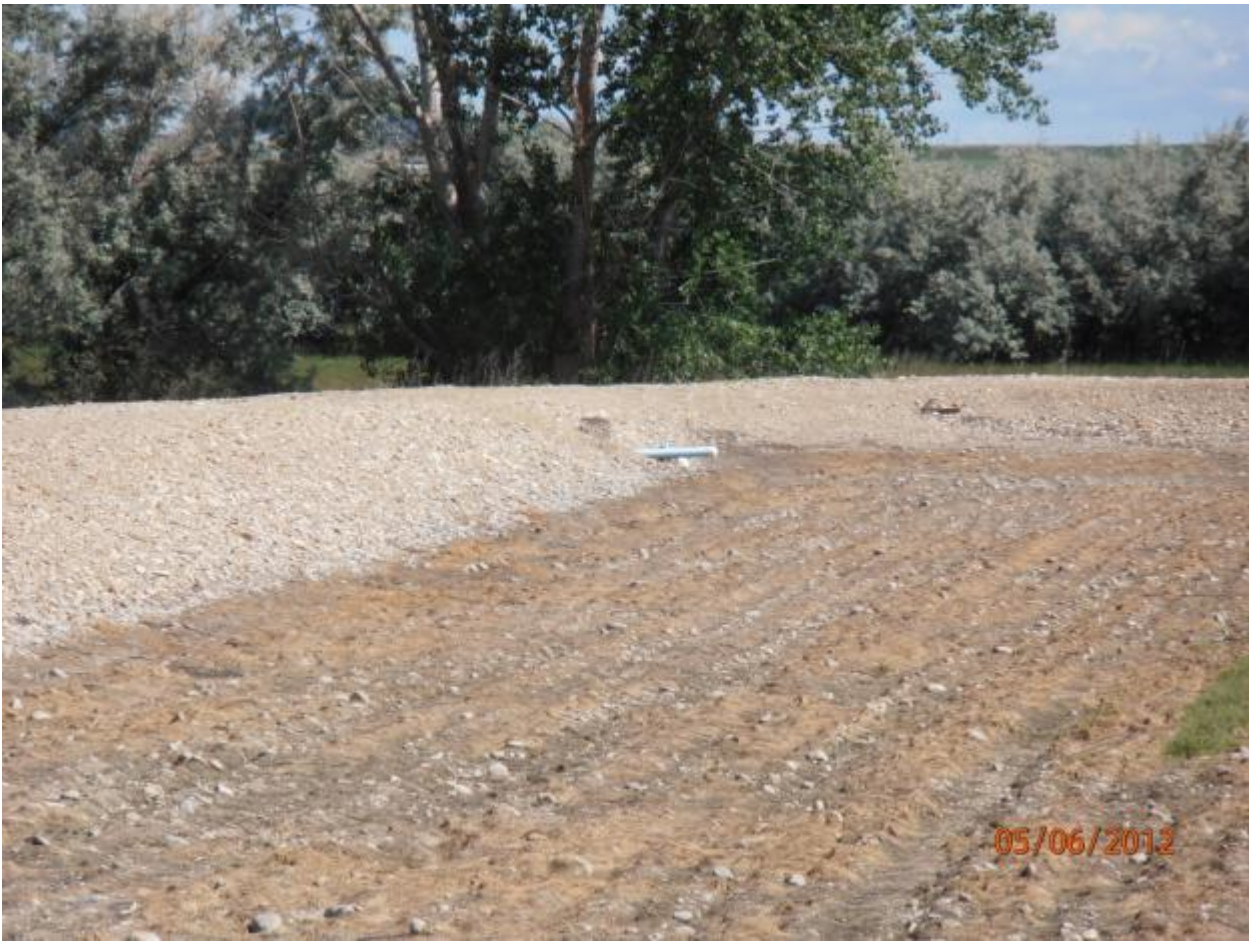
Photograph 26. Capped pipe at northwest corner of Basin #4.

Facing north. Discharge pipe capped at northwest corner of infiltration basin.

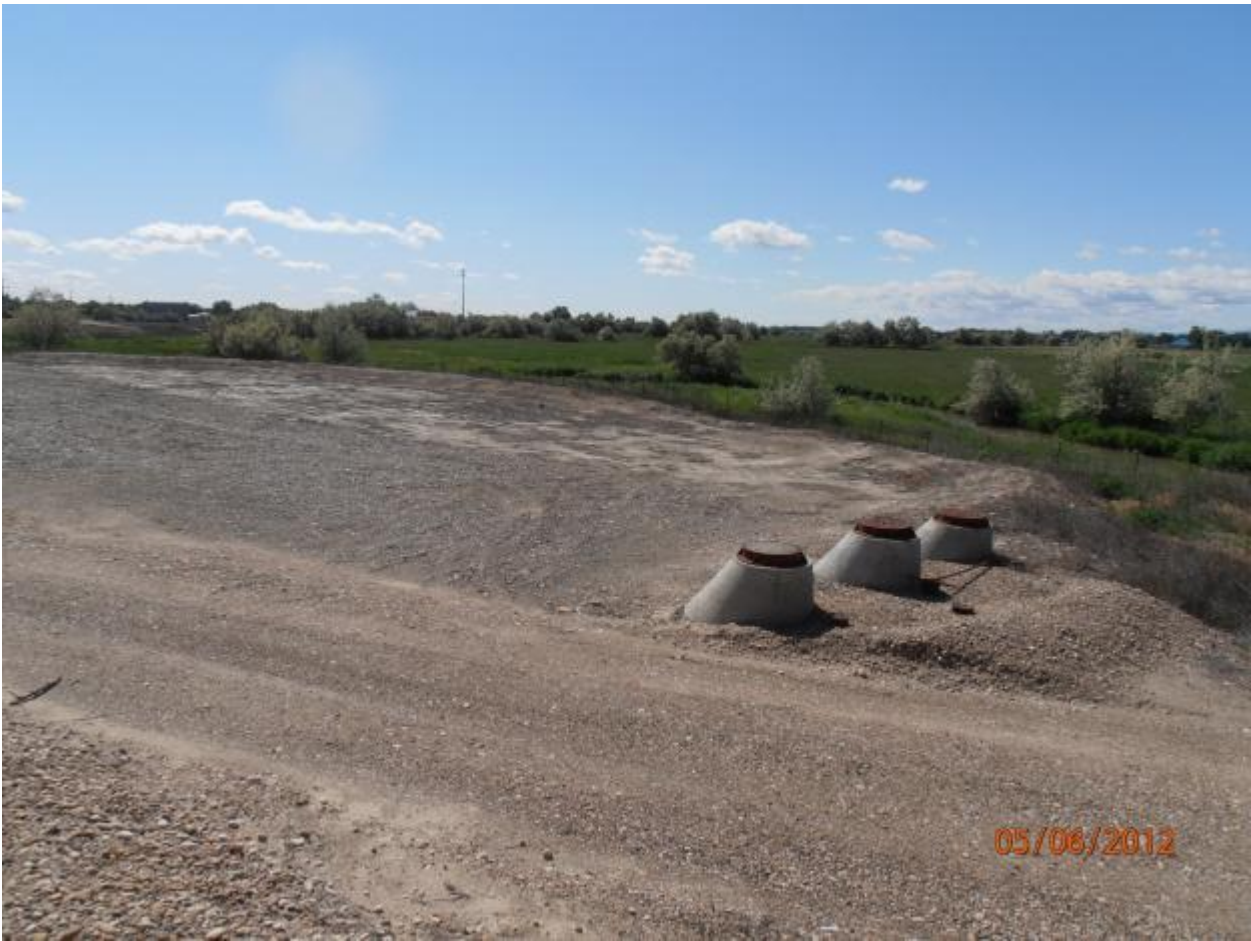
Photograph 27. Chlorination contact chamber access.

Facing south. Manholes provide access to chlorine contact basin, composed of multiple Ø48 inch pipes.

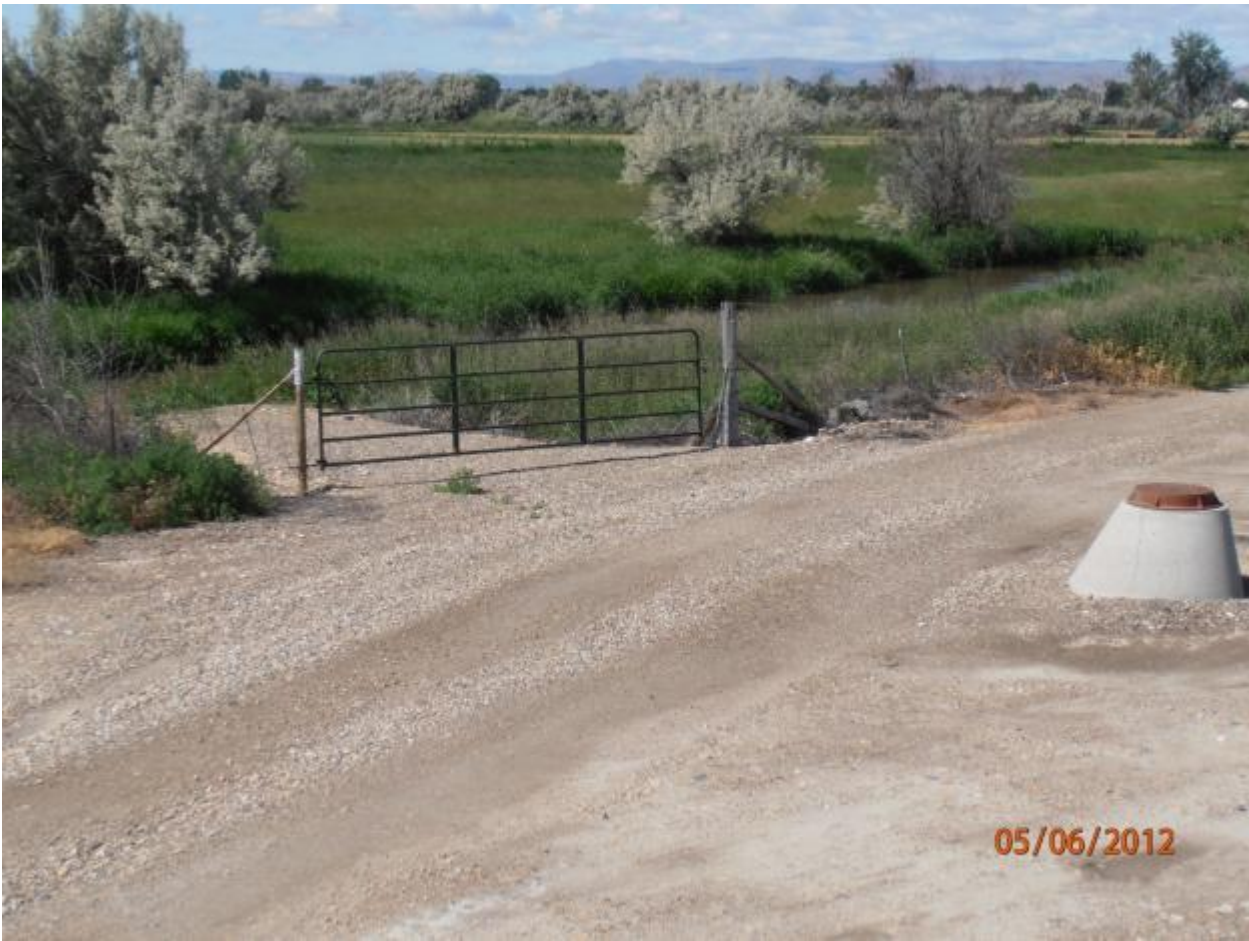
Photograph 29. Discharge point access and access manhole.

Facing southwest. Discharge point to Sandhollow Creek located through gate. Manhole provides access to discharge piping and is turning point for effluent flow from chlorination contact basin toward creek.

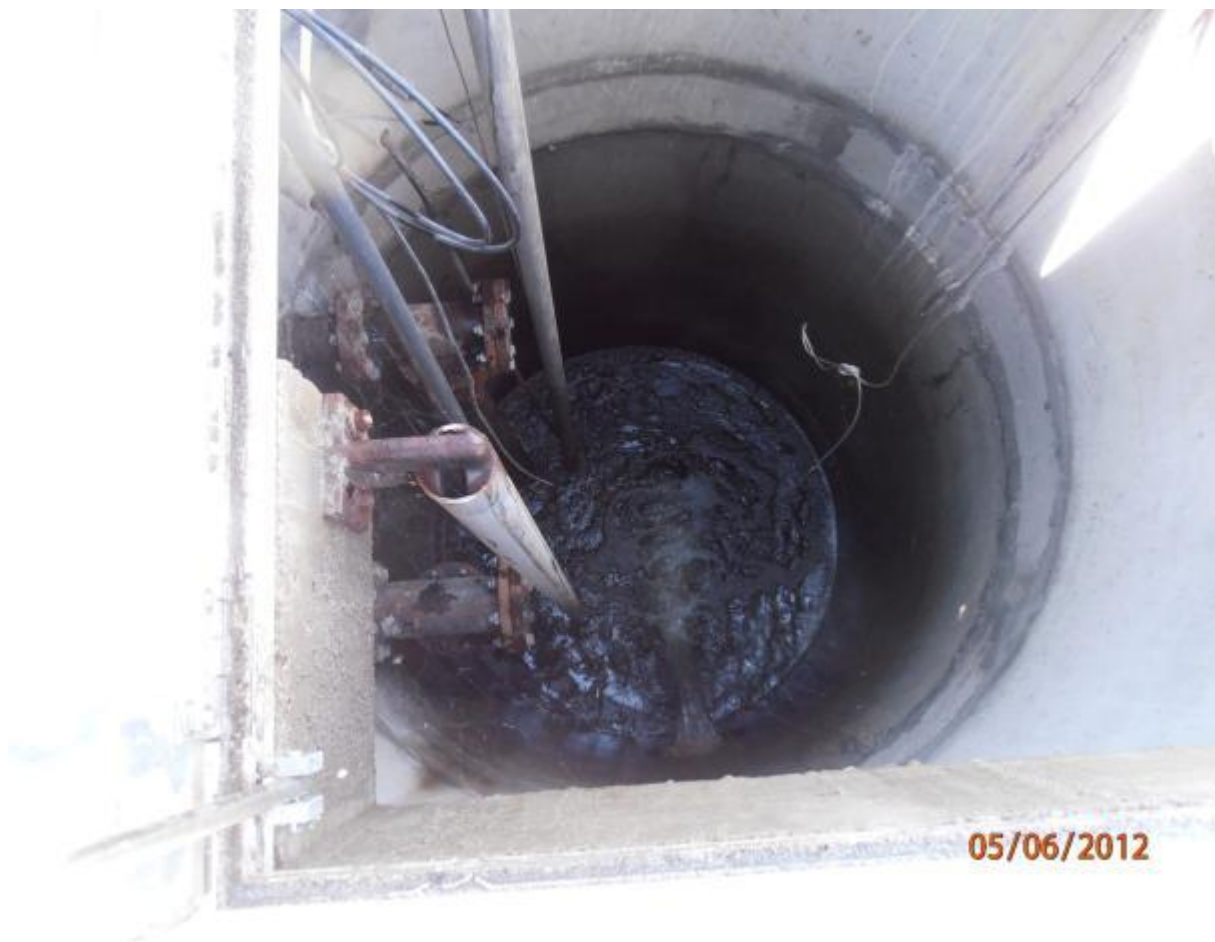
Photograph 30. Underdrain collection well and float controls.

Filtration basins' Underdrain Collection System discharges to this float-controlled wet well, which lifts effluent to Chlorination System.

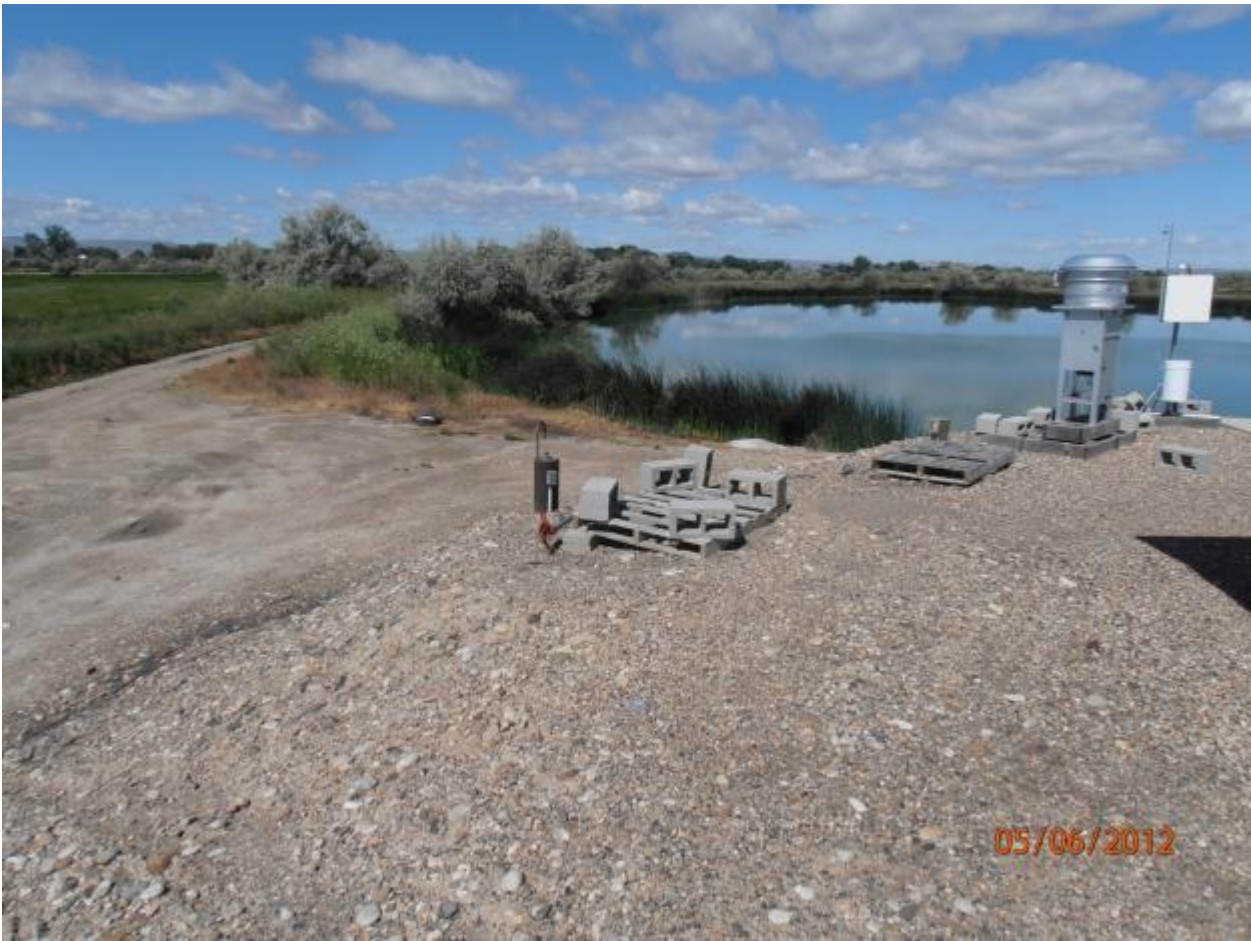
Photograph 35. Well head for site well. Well supplies water for chlorine injection.

Facing west towards water-filled gravel pit, which supplied materials to construct the infiltration basins.

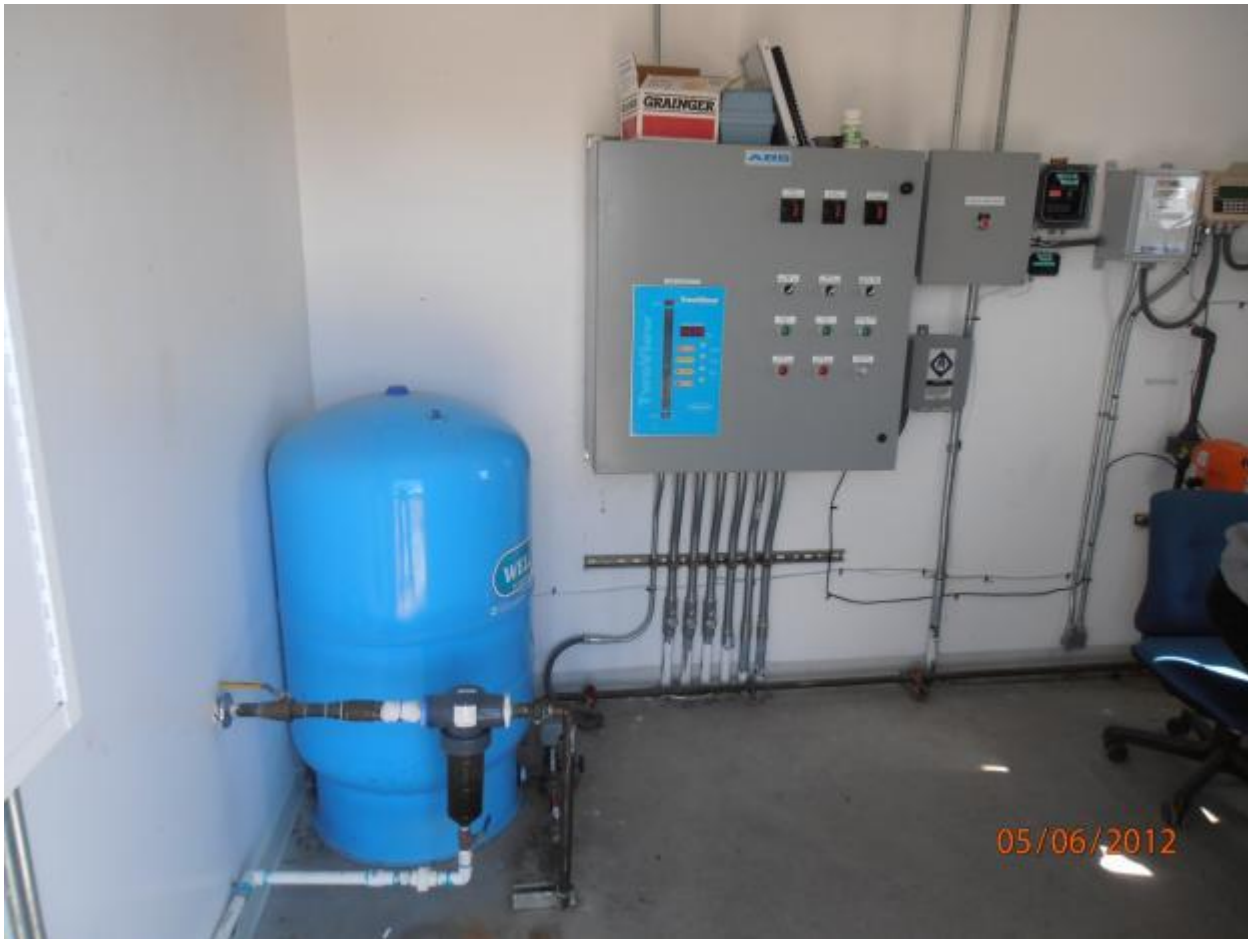
Photograph 36. Well head and pump controls.

Room at southeast corner of Chlorination Building provides room to perform water quality tests that must be done immediately; temperature, pH, DO.

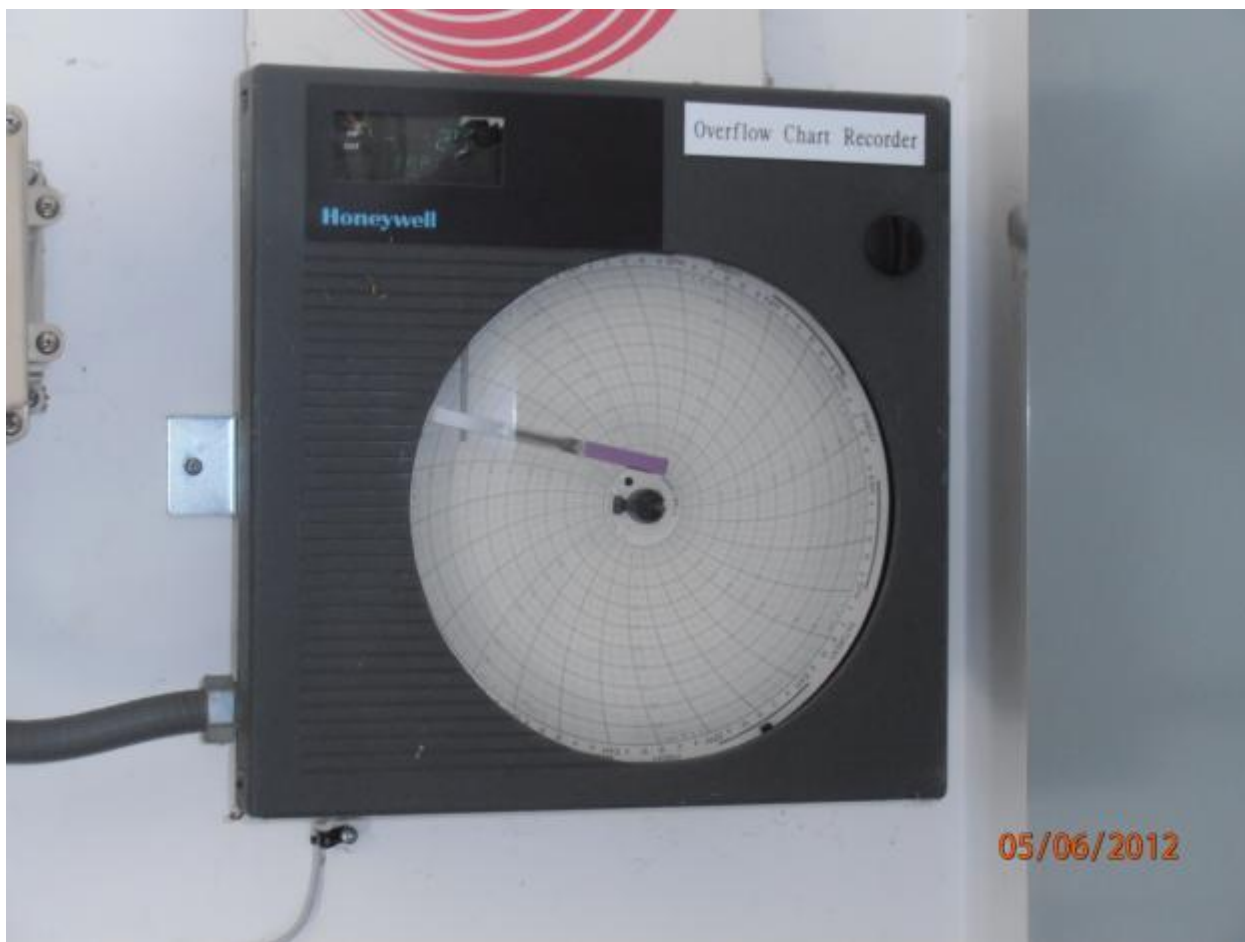
Photograph 39. Overflow chart recorder.

Located in Chlorination Building's southeast room.

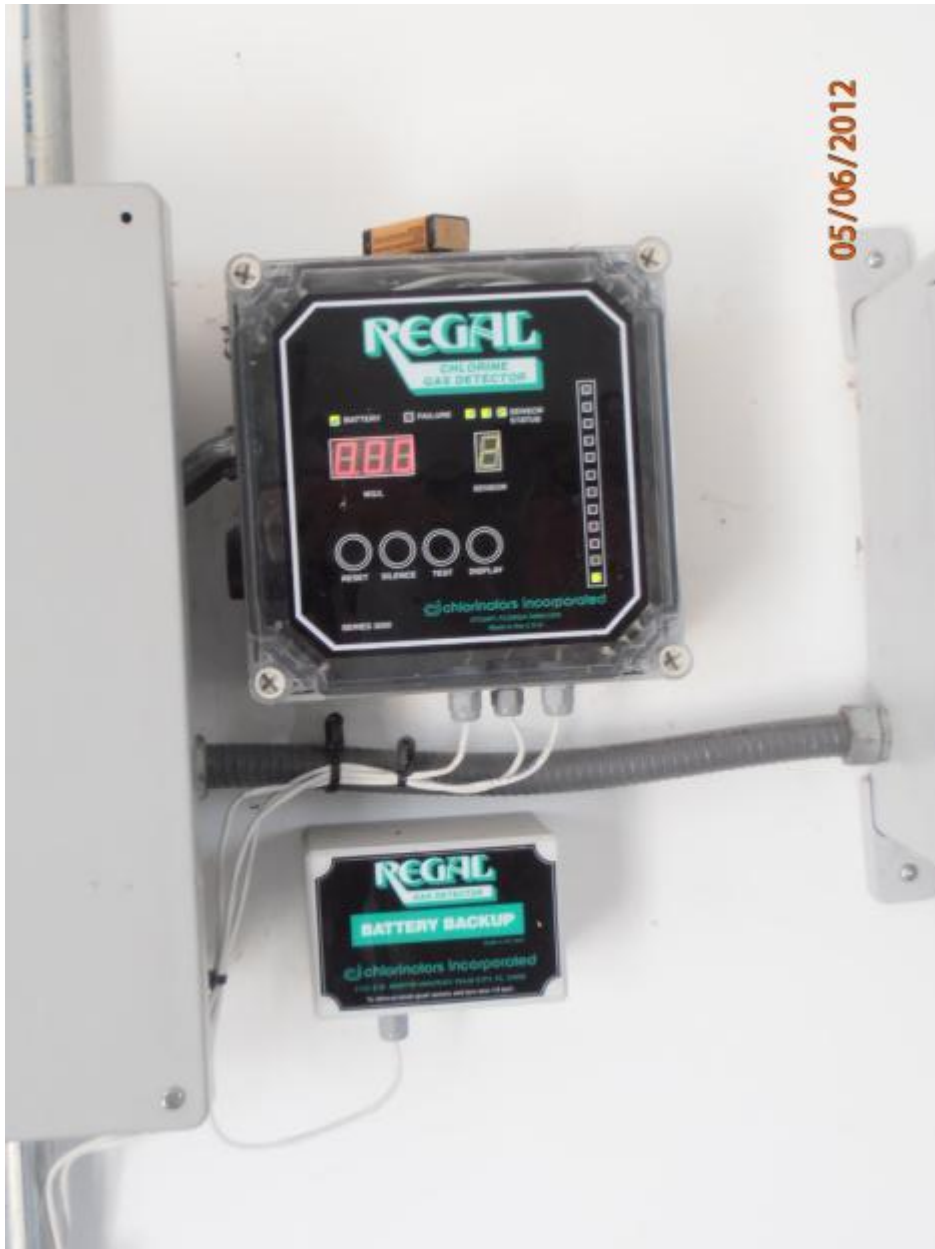
Photograph 40. Chlorine gas detector.

Located in Chlorination Building's southeast room.

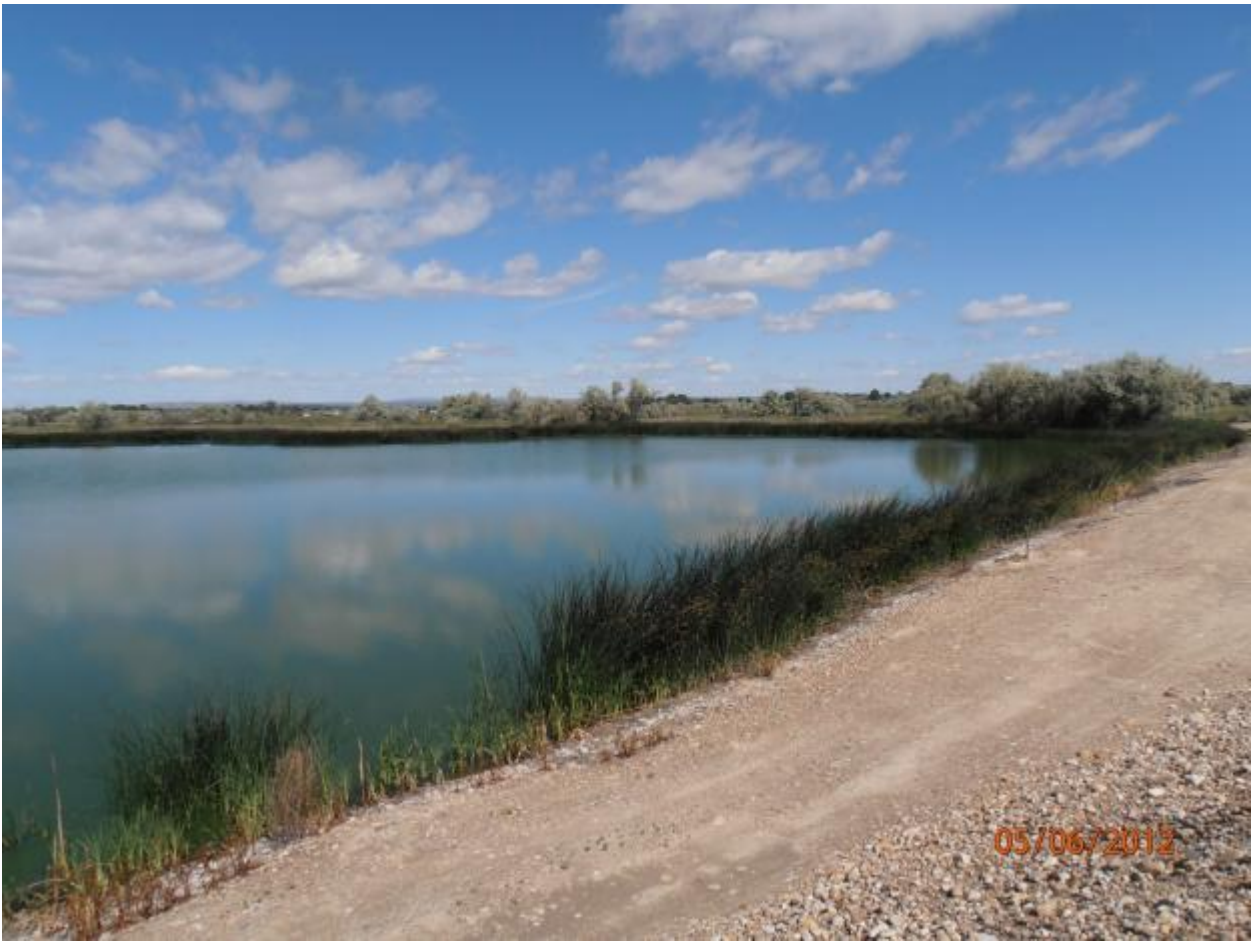
Photograph 45. Pond resulting from gravel and sand extraction used to build infiltration basins.

Facing northwest. Pond is not part of Parma WWTF.

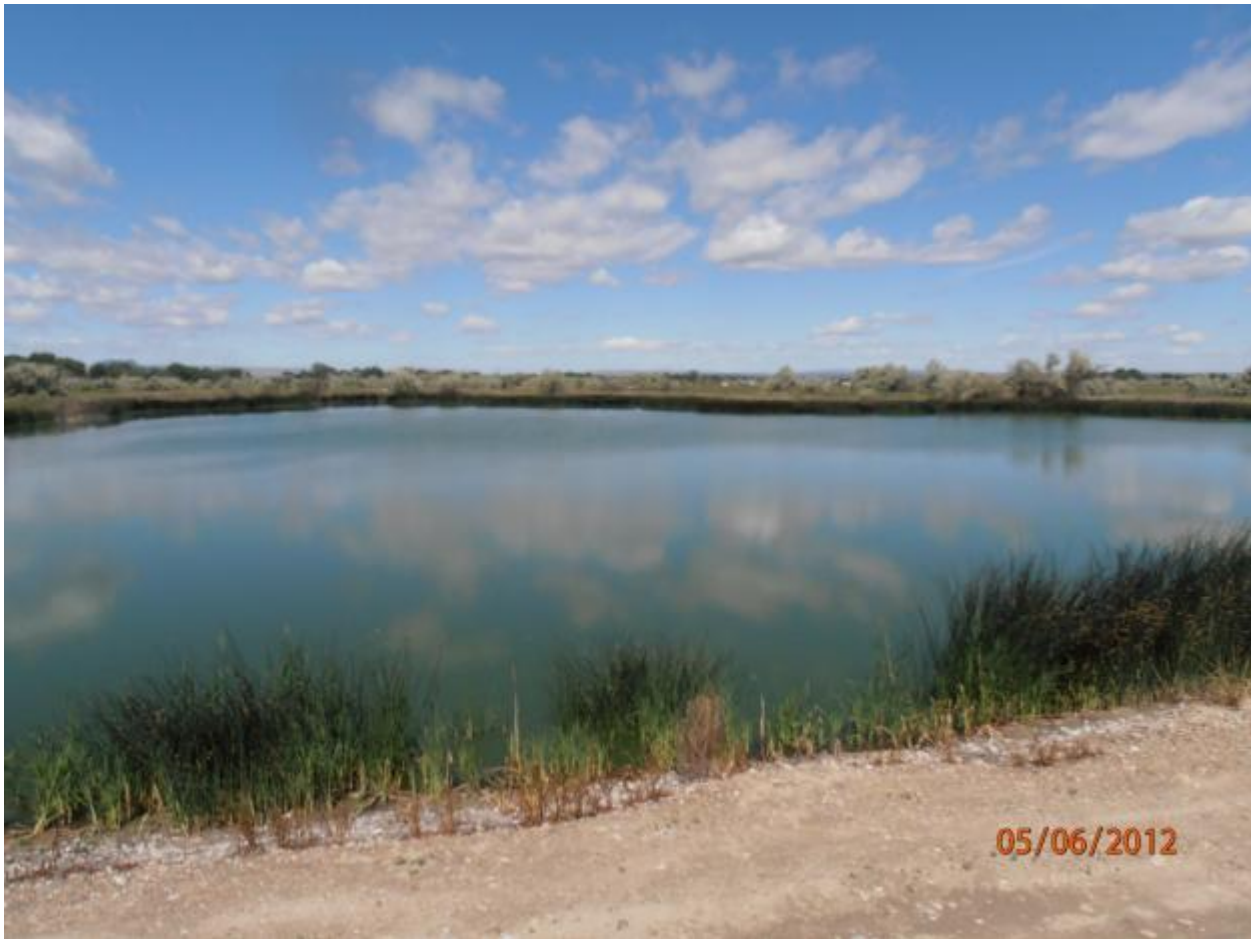
Photograph 46. Adjacent sand and gravel pond that supplied materials for infiltration basin construction.

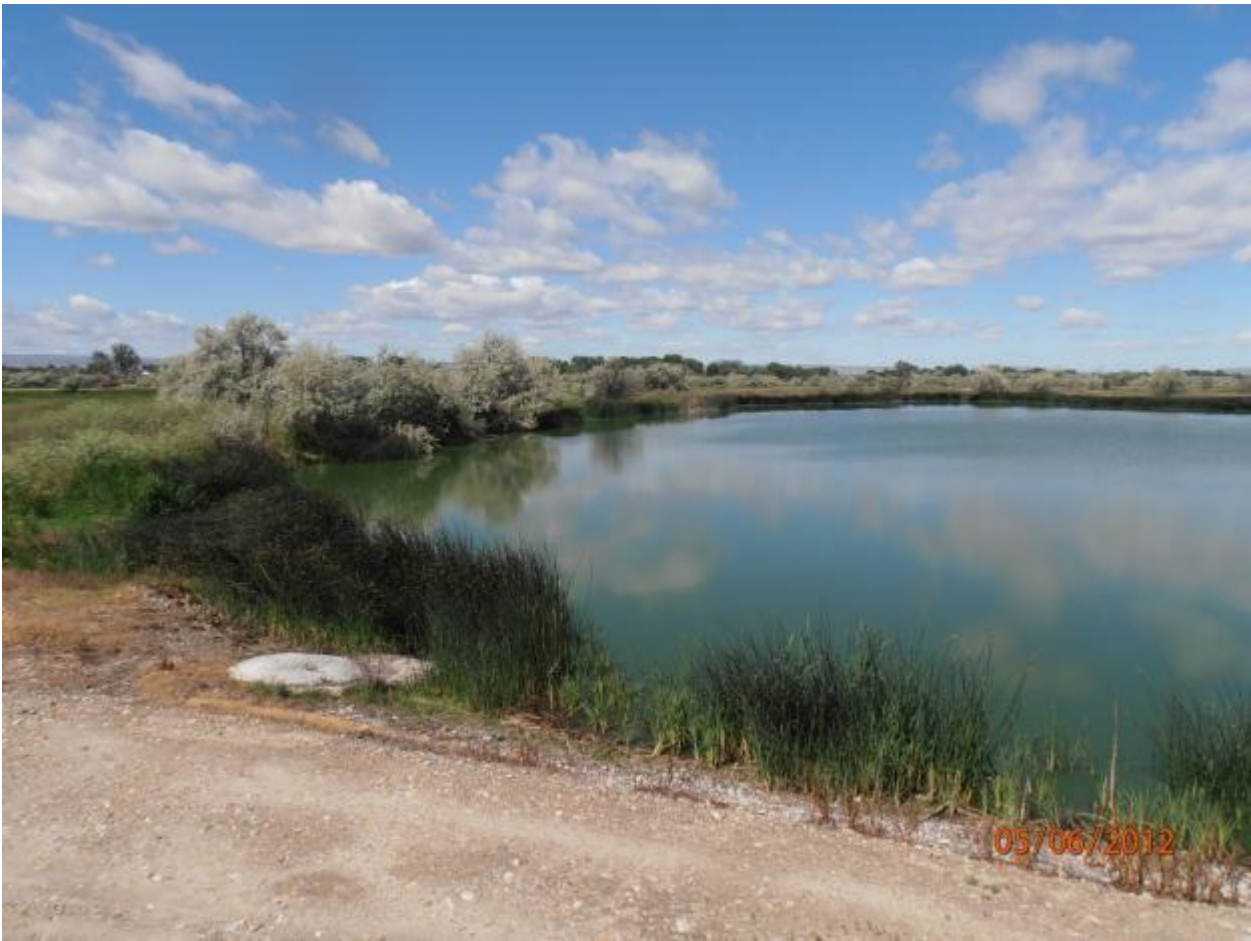
Photograph 47. Sand and gravel pond where materials for infiltration basin construction were obtained.

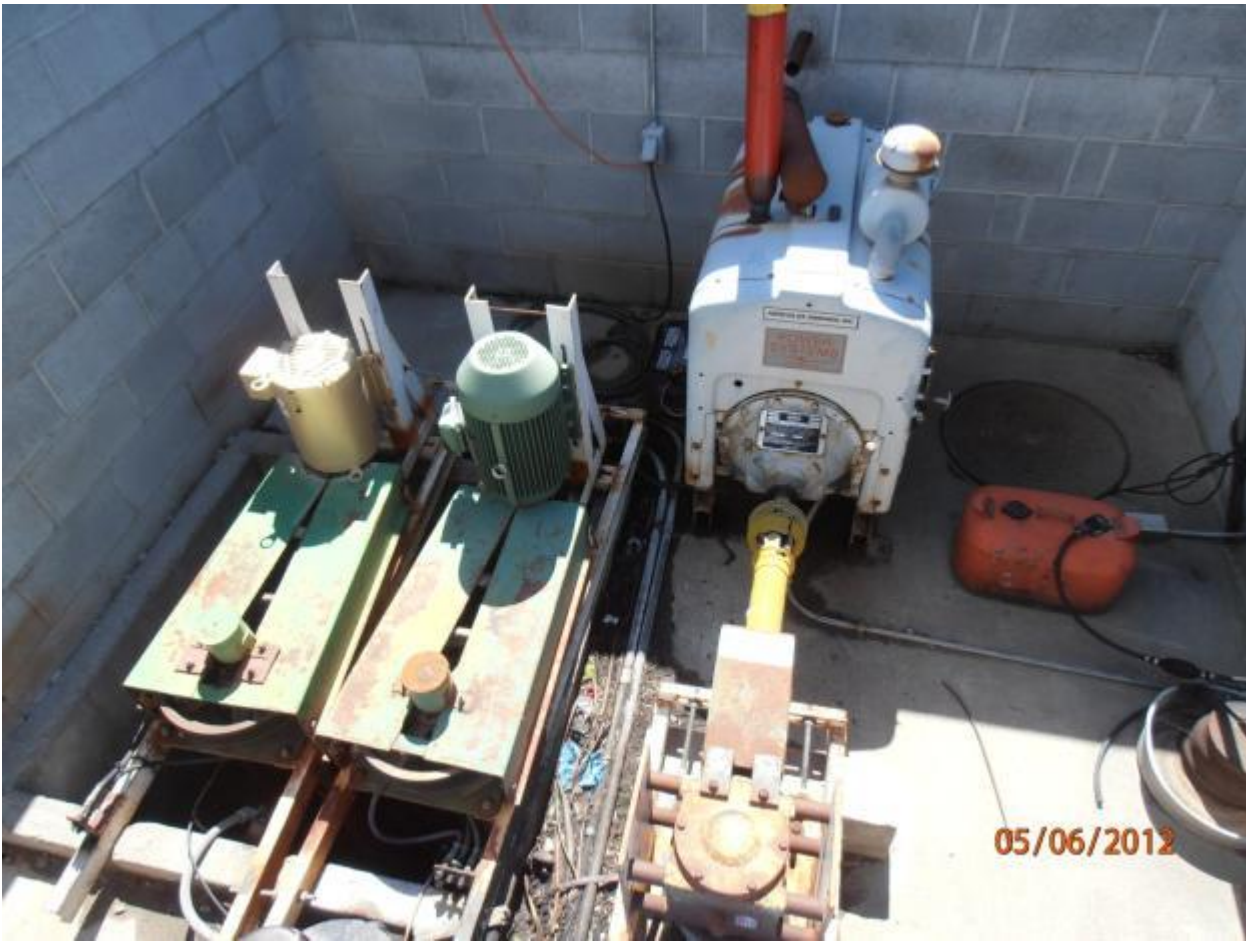
Photograph 48. Wastewater lift station with backup pump engine.

Lift station that sends raw wastewater to Lagoon #1. Lift station is located about 470 feet east of lagoon area gate.

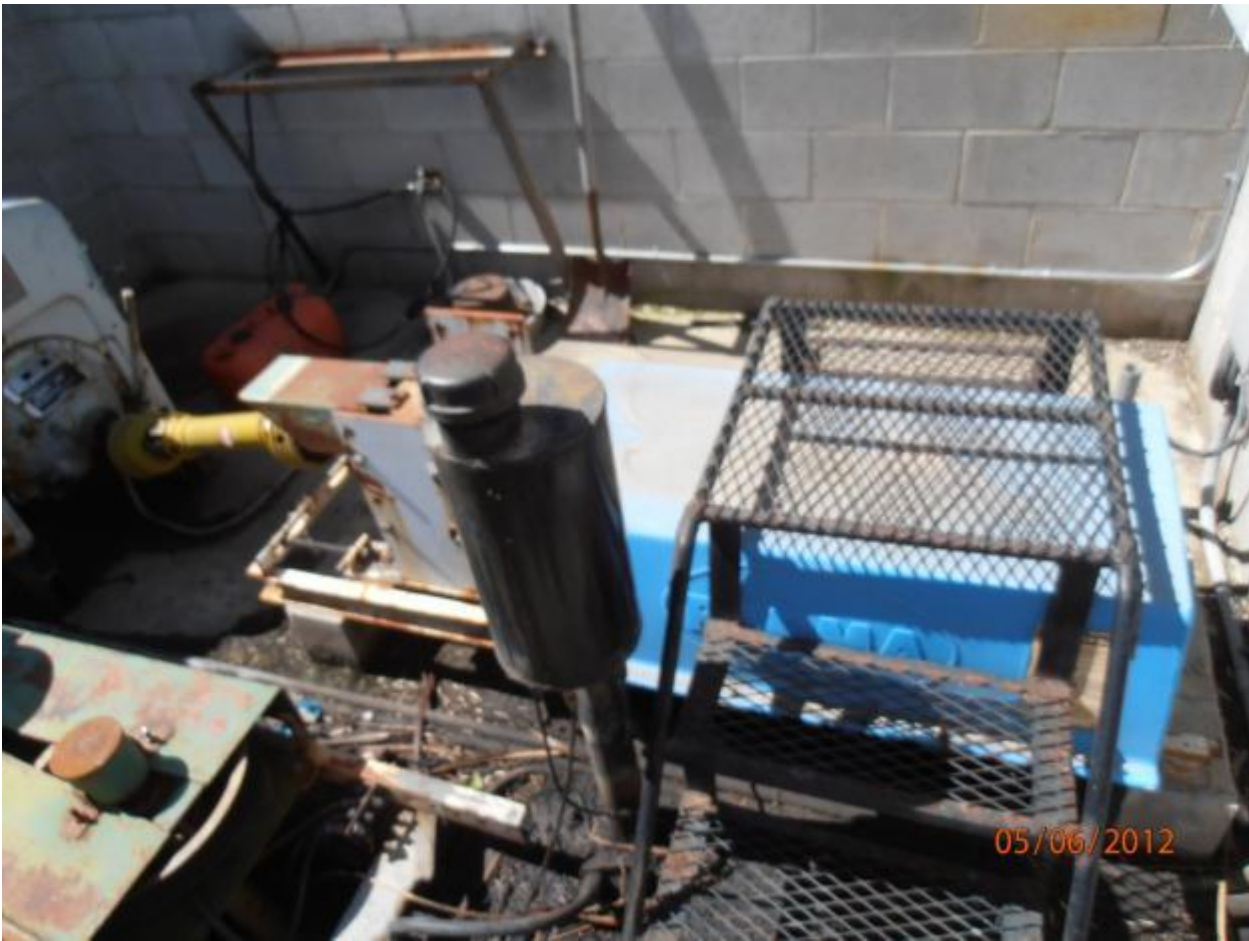
Photograph 49. Backup pump water lifter.

Water lift brand pump attached to backup engine.

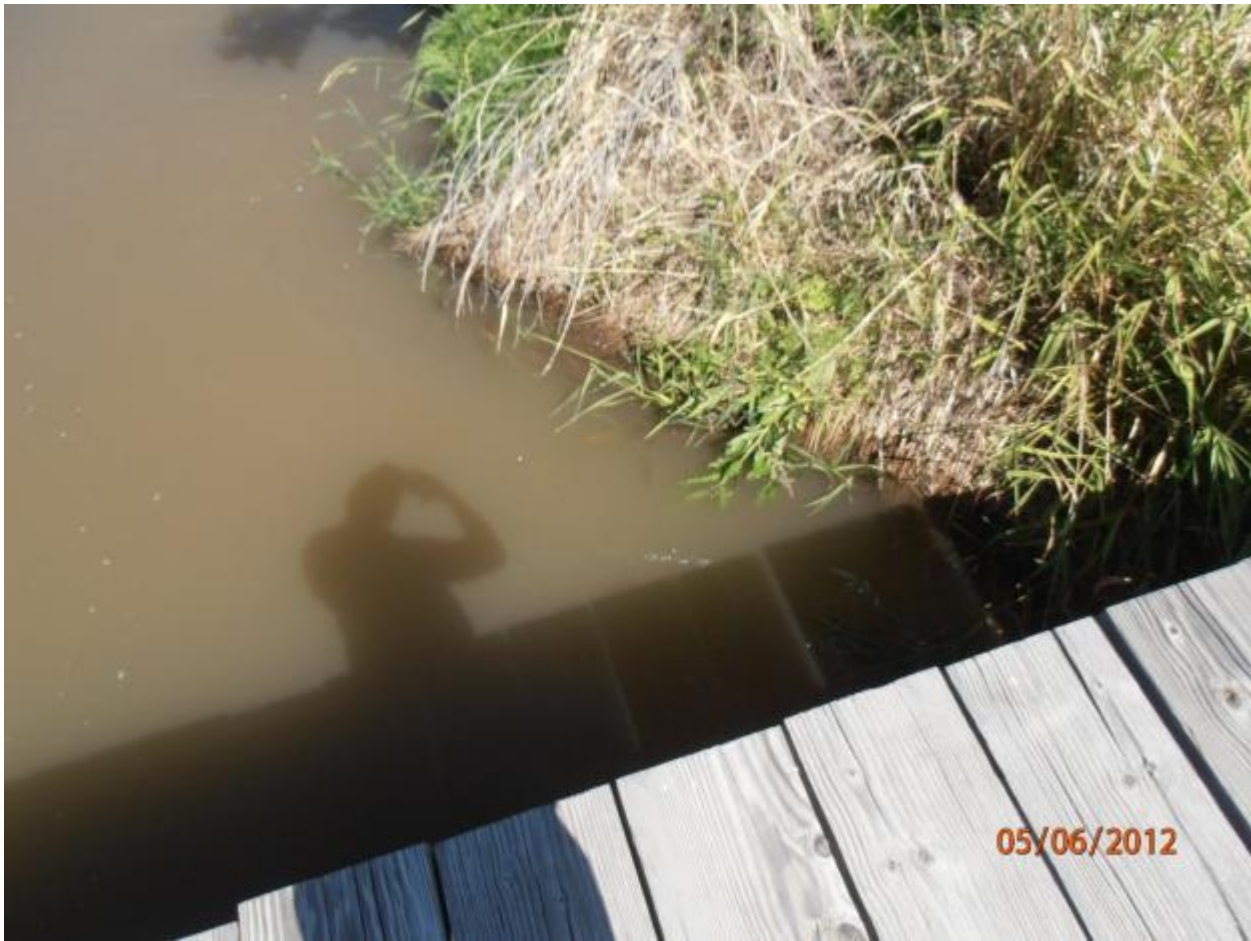
Photograph 50. Upstream sample extraction point in Sandhollow Creek.

Sampling location from bridge located approximately 75 feet west southwest of lift station.

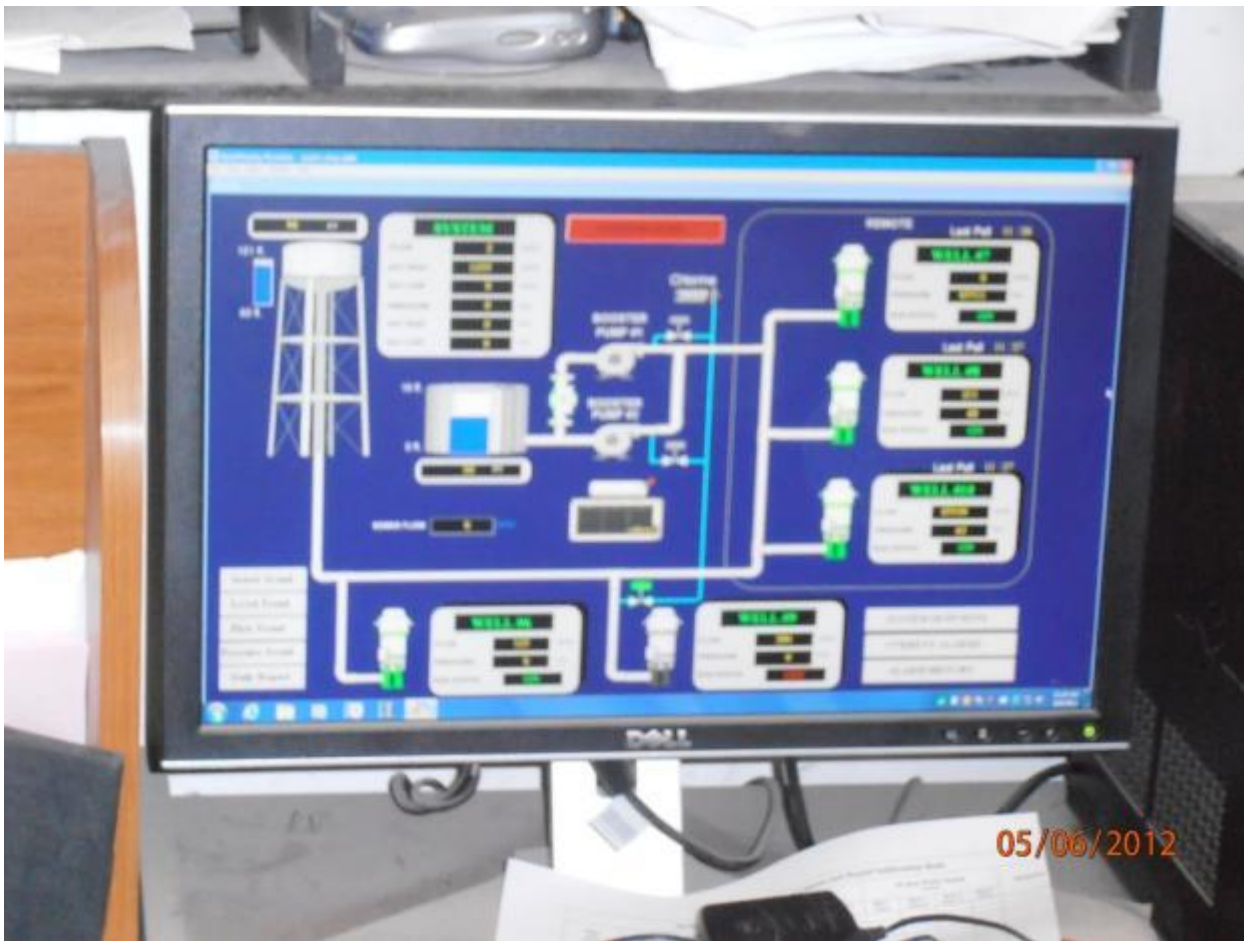
Photograph 52. Screen shot of SCADA System.

Located in the back of the City Shop Building.

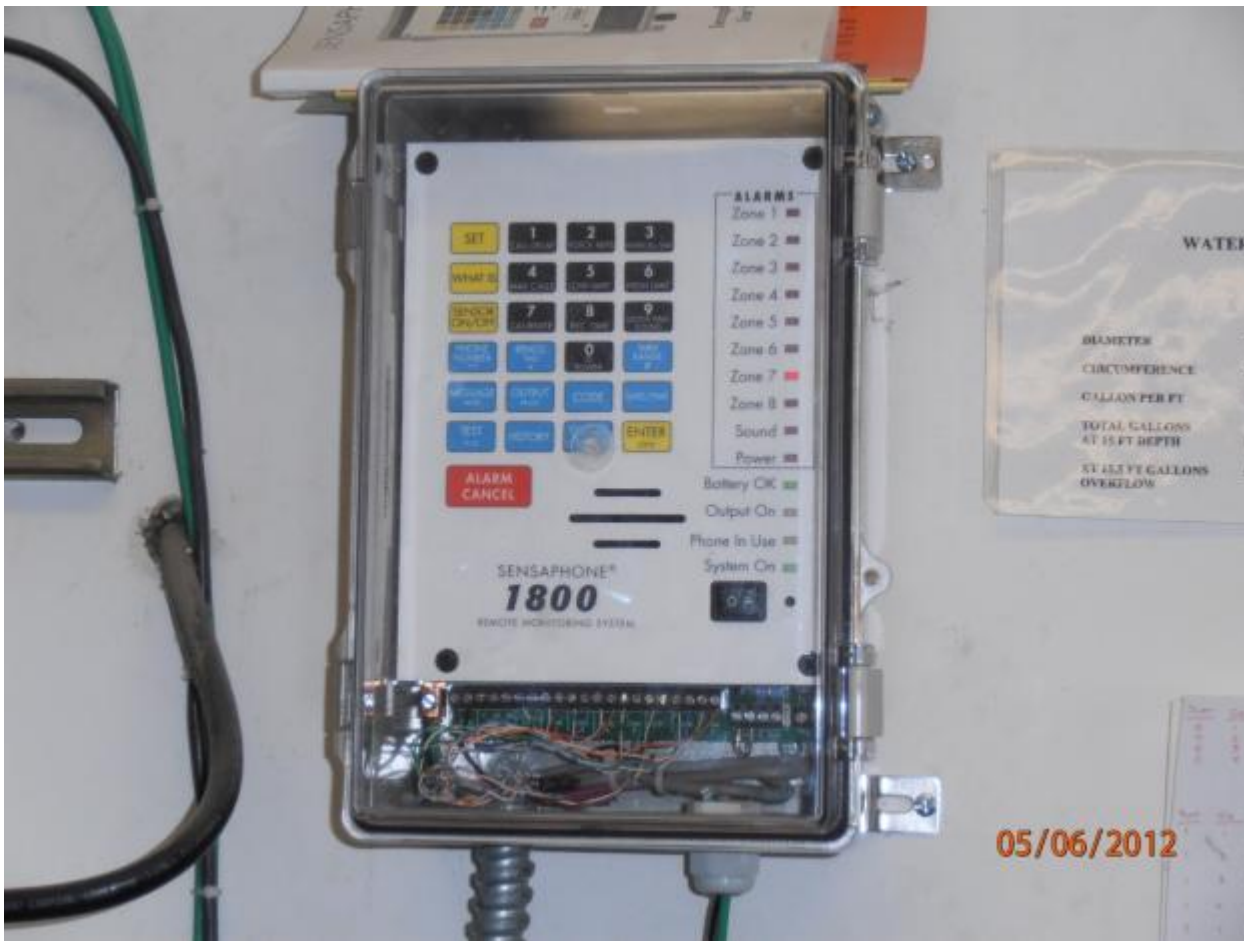
Photograph 53. Auto dialer.

Located in City Shop Building adjacent to SCADA System.

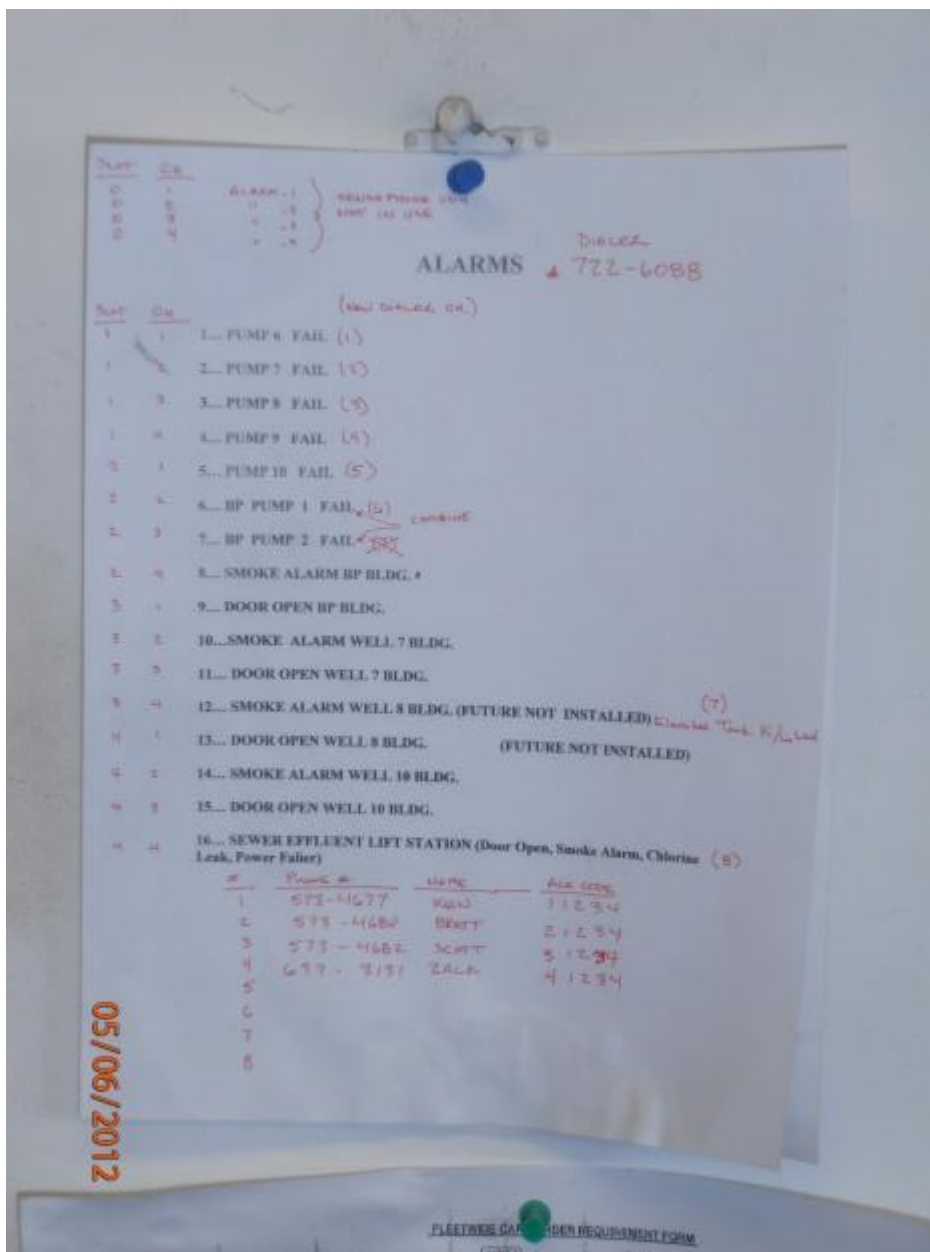
Photograph 54. Alarm list.

Alarm list is posted on the wall adjacent to the auto dialer.

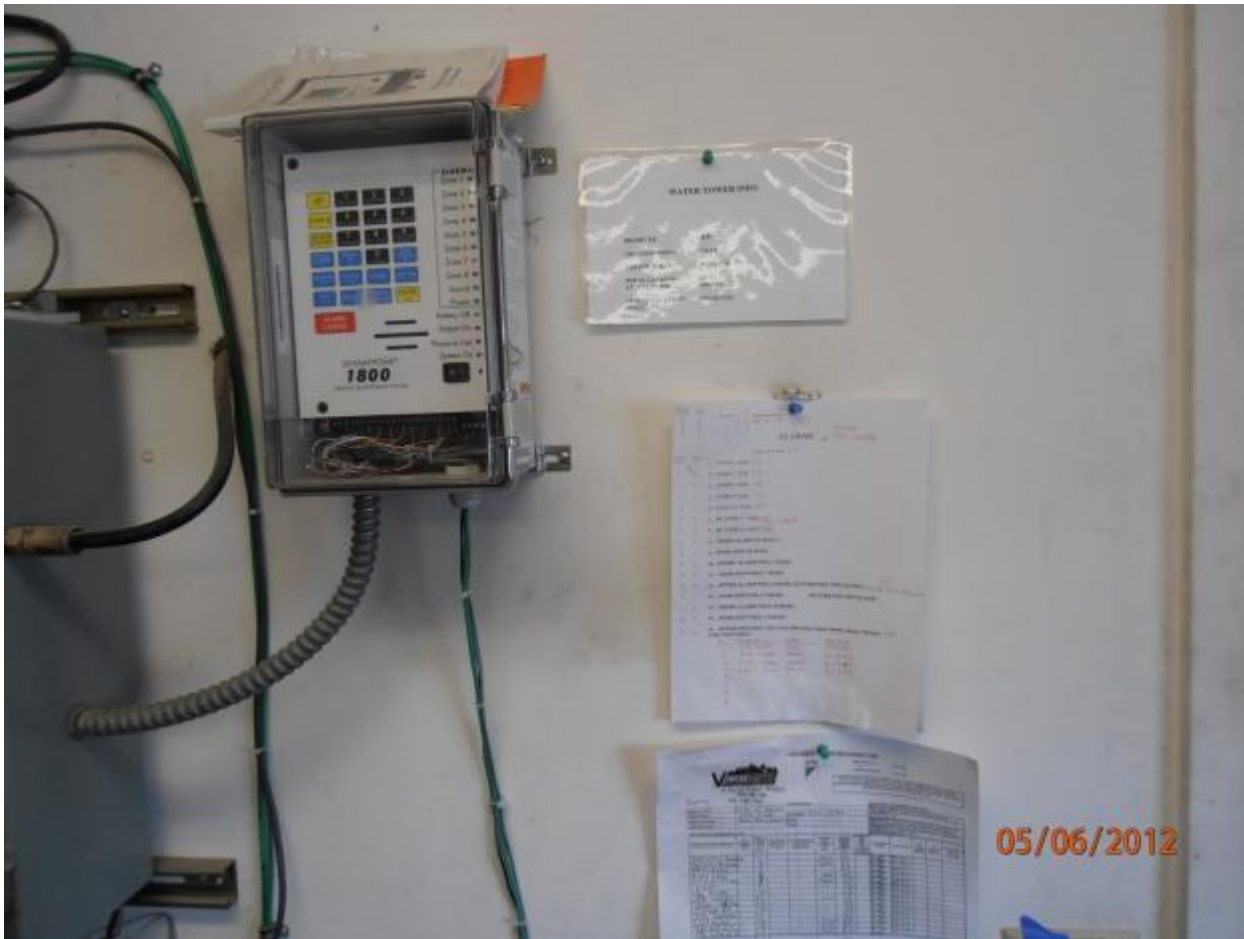
Photograph 55. Auto dialer and alarm list.
